**CHARACTERISTIC INFLUENCE OF THERMO-MECHANICAL STRESSES
LEADING TO PREMATURE FAILURE OF COMPRESSOR TURBINE BLADES OF
SHORT-HAUL AIRCRAFT FLEET**

A THESIS SUBMITTED IN FULFILLMENT OF THE REQUIREMENTS FOR DEGREE

DOCTOR OF PHILOSOPHY IN ENGINEERING

AT THE UNIVERSITY OF BOTSWANA

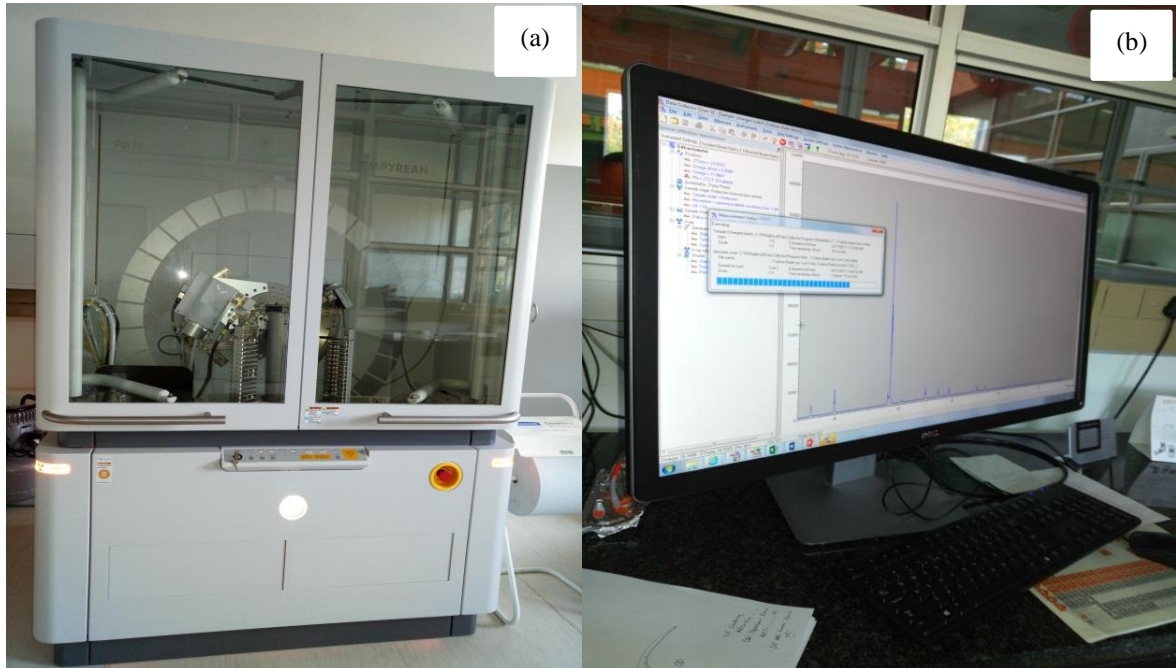
Figure 4. 3: (a) PANalytical Expert Pro XRD machine (b) Display of sample data

The Empyrean XRD machine, PANalytical, Expert Pro, appearing in Fig. 4.3 was used for data acquisition. The samples were cleaned, placed on a zero-background holder and pressed to make a 5mm radius circle at STP in conformity to ASTM E1834-11. Scan Axis Gonio settings were applied prior to spinning with $K\alpha Cu$ radiation from start position $33.64 [^\circ 2\theta]$ to end position $93.08 [^\circ 2\theta]$ with a Step Size of $0.02 [^\circ 2\theta]$ and Step Time of $1.00 [s]$. X'Pert High Score Plus, V4.5 software was then used for analyses.

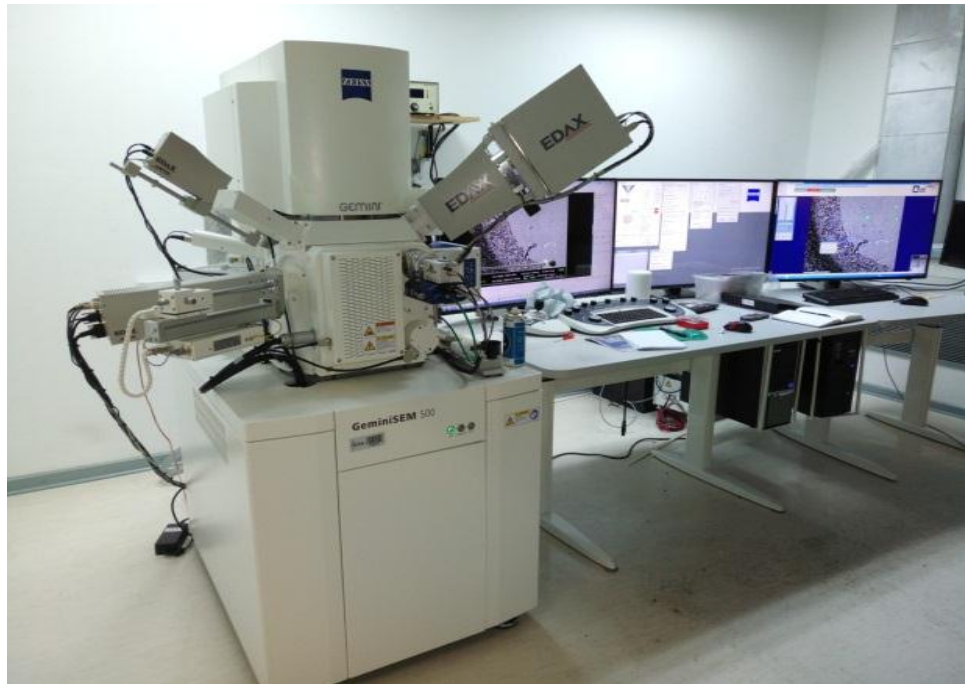
Figure 4. 4: ZEISS Gemini 500, EDS enabled SEM

The non-sectioned samples of the CT blades majorly represented the diffusion aluminide protective coating. The samples were cleaned ultrasonically with ethanol, dried and subjected to SEM for surface and sub-surface damage identification and quantification at the tips, airfoils and bases. The micrographs then subjected for analyses using an EDS enabled SEM, ZEISS; Gemini 500 illustrated in Fig. 4.4 in line with ASTM E1508.

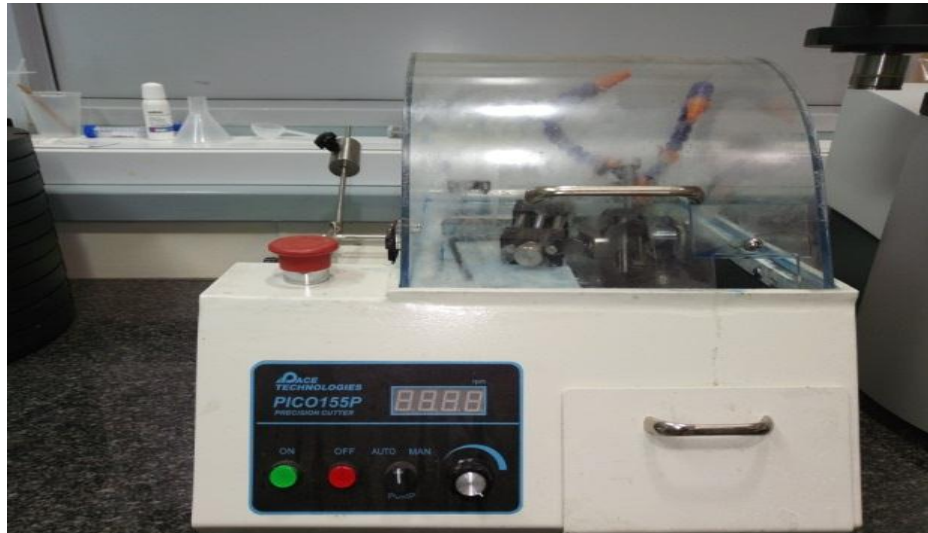
33.3%, 66.7% and 83.3% from the root of the CT blades whose heights are 36mm to give a fair representation of the base, airfoil and tip sections. The longitudinal section on the other hand was through the mid-span of the CT blade. A Dace Technologies, Picco 155P precision cutter, in Fig. 4.6 was utilized.

Figure 4. 6: Dace Technologies, Picco 155P, precision cutter

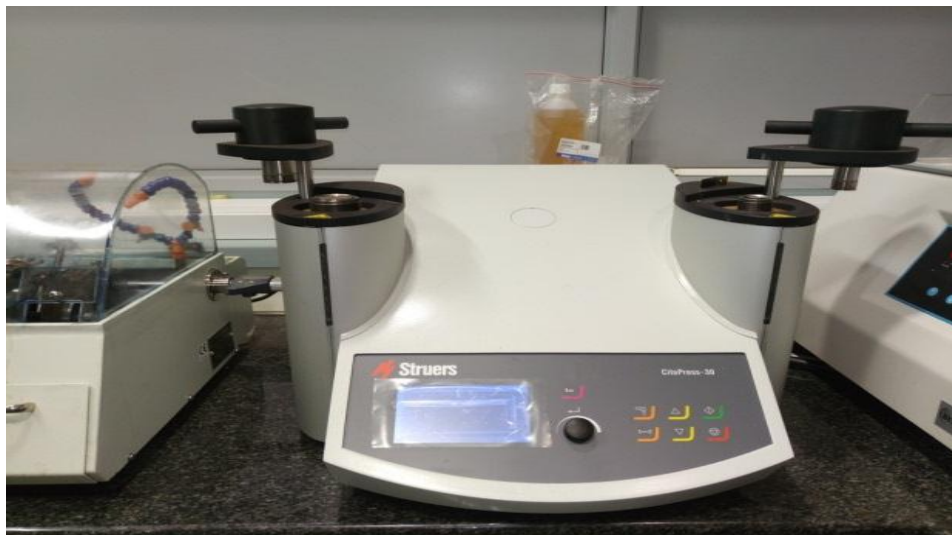
Figure 4. 7: Struers Cito Press 30, hot compression mounting machine

Mounting was carried out in hot grey acrylic thermoplastic resin to preserve the edges and make recording of specimen details possible with the aid of Struers Cito Press 30, mounting machine in Fig. 4.7.

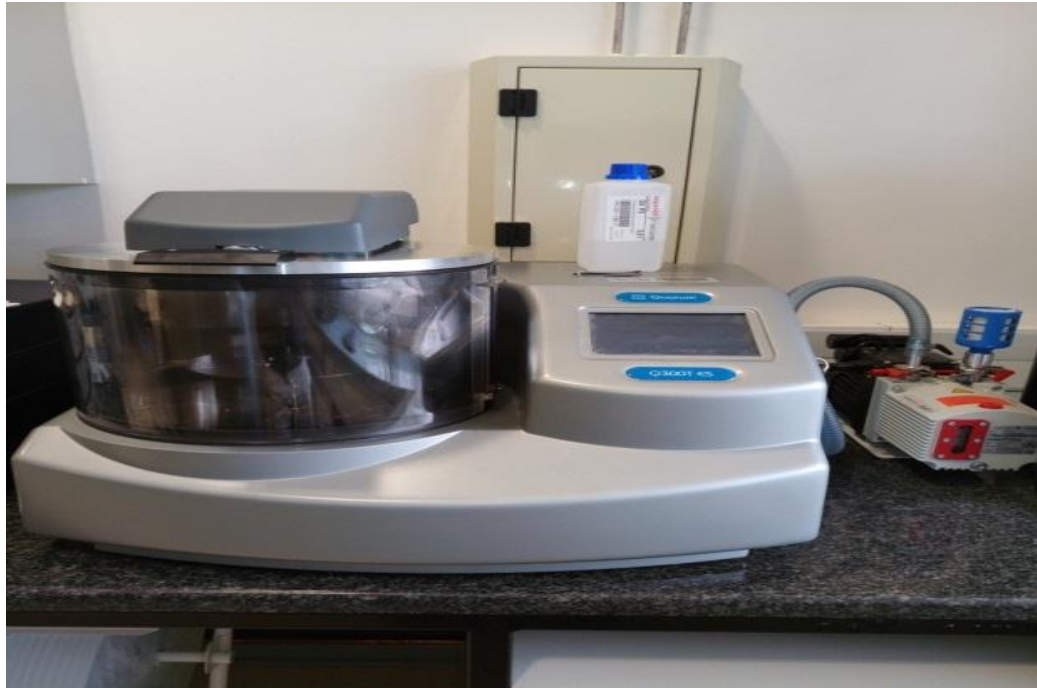
Figure 4. 8: Struers Tegramin 30, automatic grinder and polisher

Automatic simultaneous grinder and polisher, Struers Tegramin 30, in Fig. 4.8 was used to yield superior flatness, preserve the edges and clearly reveal the microstructure in Table 4.1 was adopted.

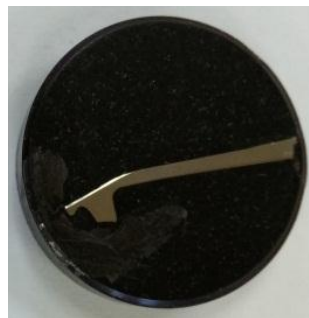
Figure 4. 11: Longitudinal section

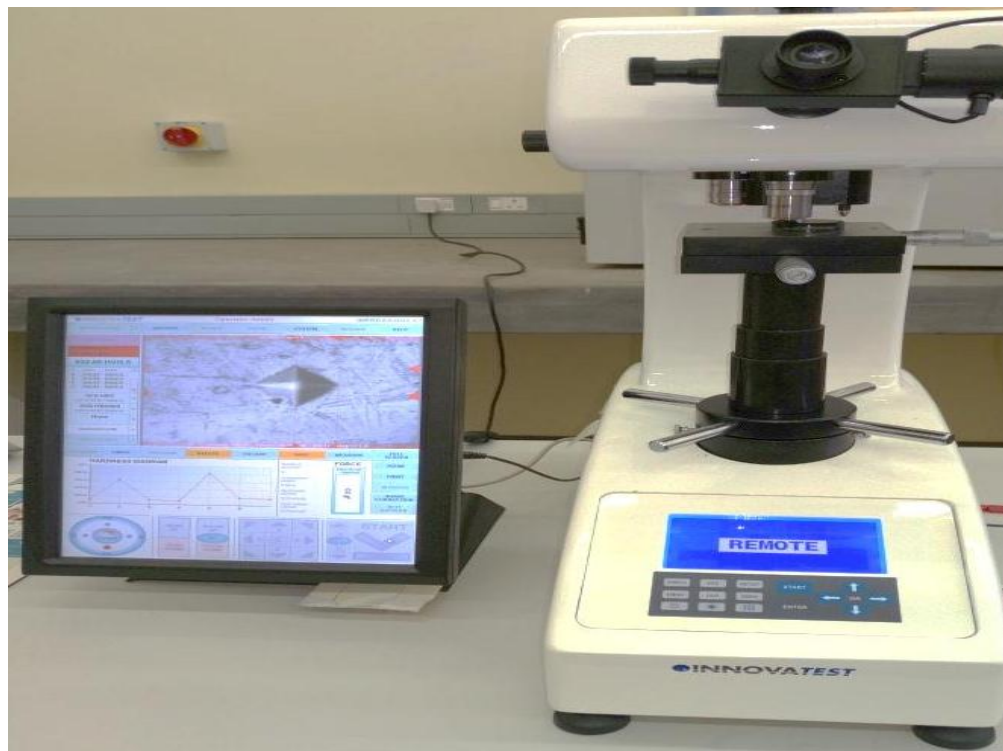
Innovatest, Nexus 4000TM, Vickers micro-hardness tester equipped with a microscope, captured in Fig. 5.1 was used for data acquisition.

Figure 5. 1: Innovatest Nexus 4000TM, Vickers micro-hardness tester

In conformity with ASTM E384, a load of 500 g force was administered with a dwell time of 10 seconds for each application. Data for the transverse sections were taken at heights
